1. REPORT NUMBER	2. GOVT ACCESSION NO.	3. RECIPIENT'S CATALOG NUMBER
4. TITLE (and Subtitle) Phase I Inspection Report New Rochelle Reservoir No. 1 Hutchinson River Basin, Westchester County, New York Inventory No. N.Y. 20		5. TYPE OF REPORT & PERIOD COVERED Phase I Inspection Report National Dam Safety Program

17. DISTRIBUTION STATEMENT (of the abstract entered in Block 20. If different from Report) National Dam Safety Program, New Rochelle Reservoir Number 1 (Inventory Number NY 20), Hutchinson River Basin, Hutchinson River, Westchester County, New York, Phase I Inspection Report,

PHASE 1 INSPECTION REPORT
NATIONAL DAM SAFETY PROGRAM
NEW ROCHELLE RESERVOIR No. 1 DAM NY 20
HUTCHINSON RIVER BASIN
WESTCHESTER COUNTY, N.Y.

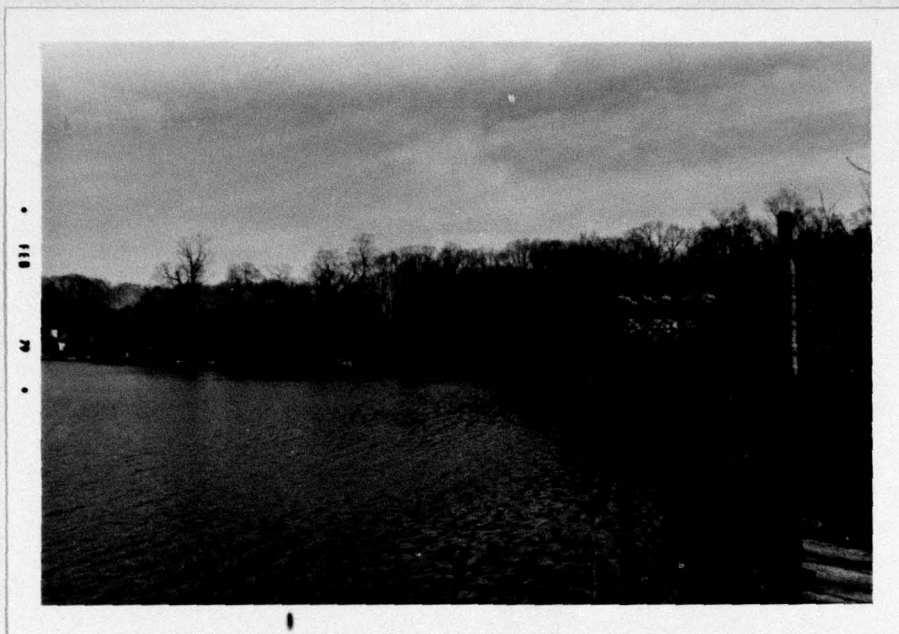
NEW ROCHELLE RESERVOIR No. 1 DAM
OVERVIEW - NORTHEASTERN END

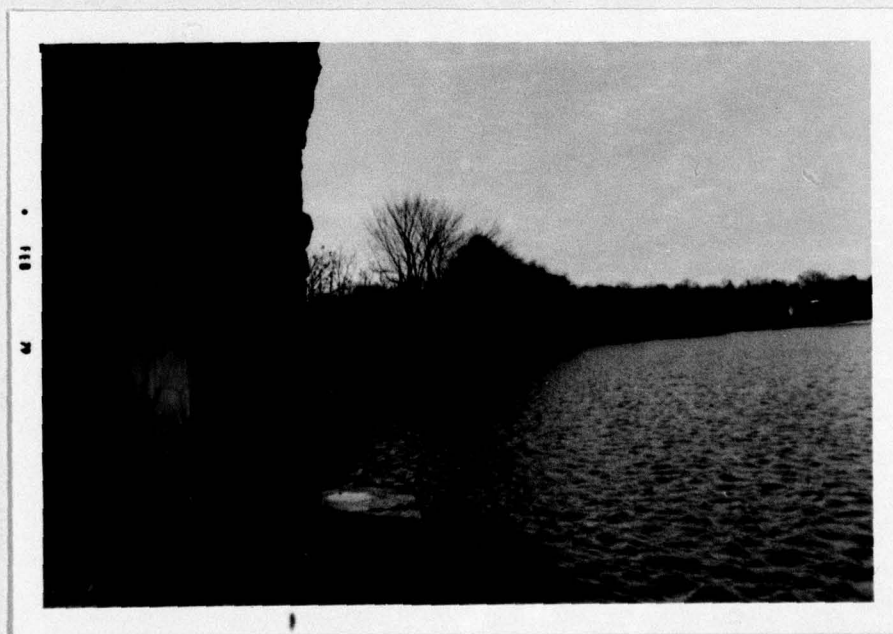
OVERVIEW - SOUTHWESTERN END

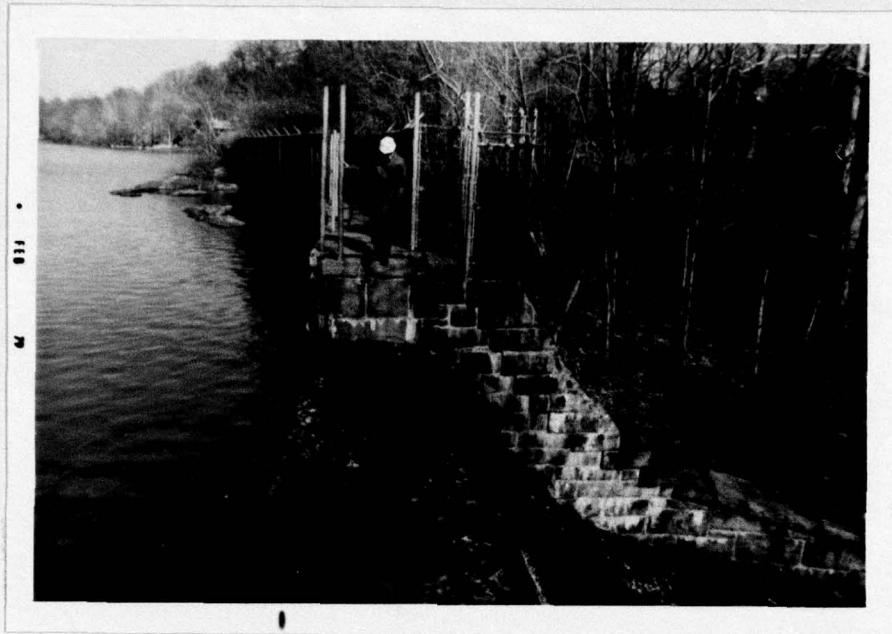
The spillway channel was in satisfactory condition. There was some mortar missing from the joints between blocks near the spillway crest, but generally the spillway was in satisfactory condition.

SPILLWAY CREST

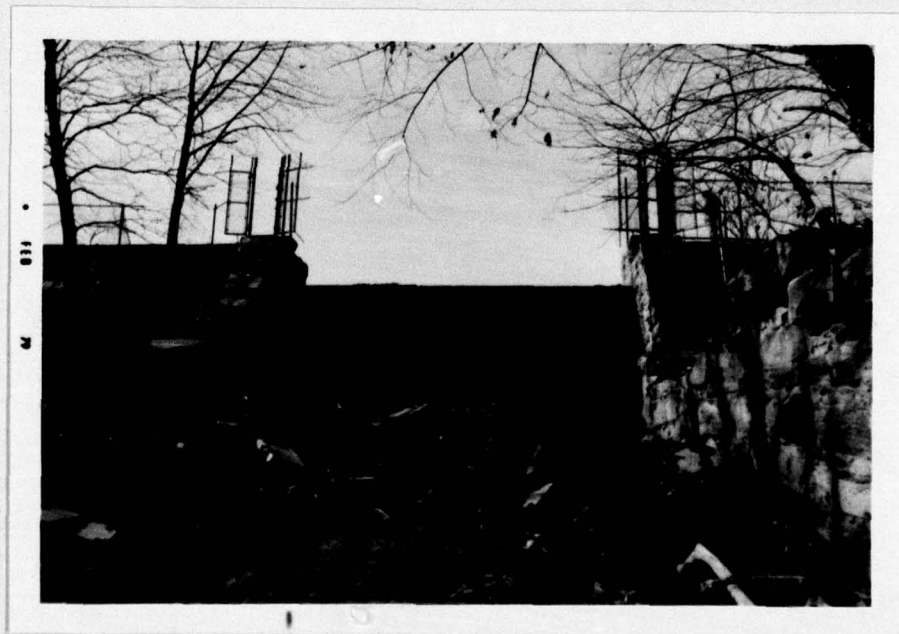
SERVICE SPILLWAY LOOKING UPSTREAM

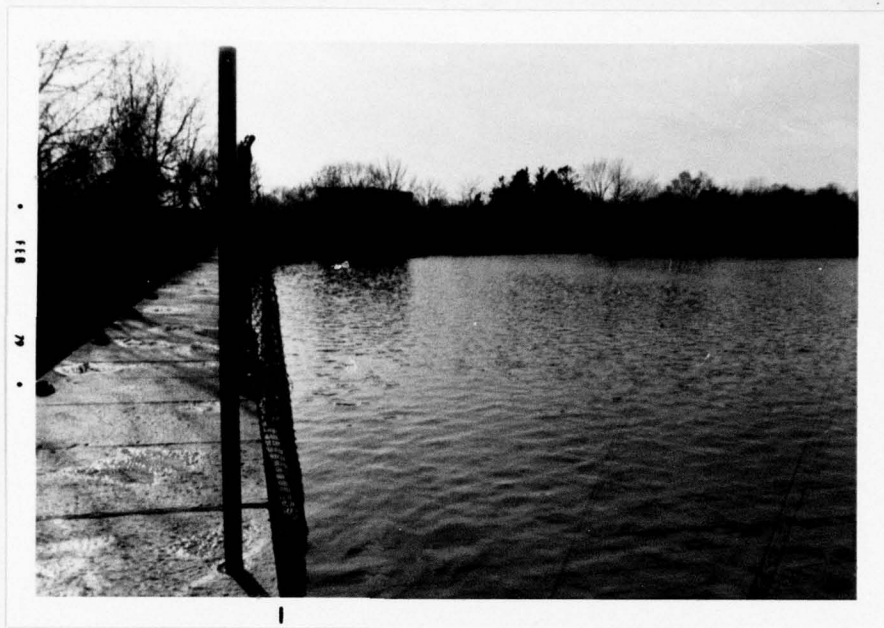
CREST OF NON-OVERFLOW MASONRY SECTION
WITH "GATE HOUSE"

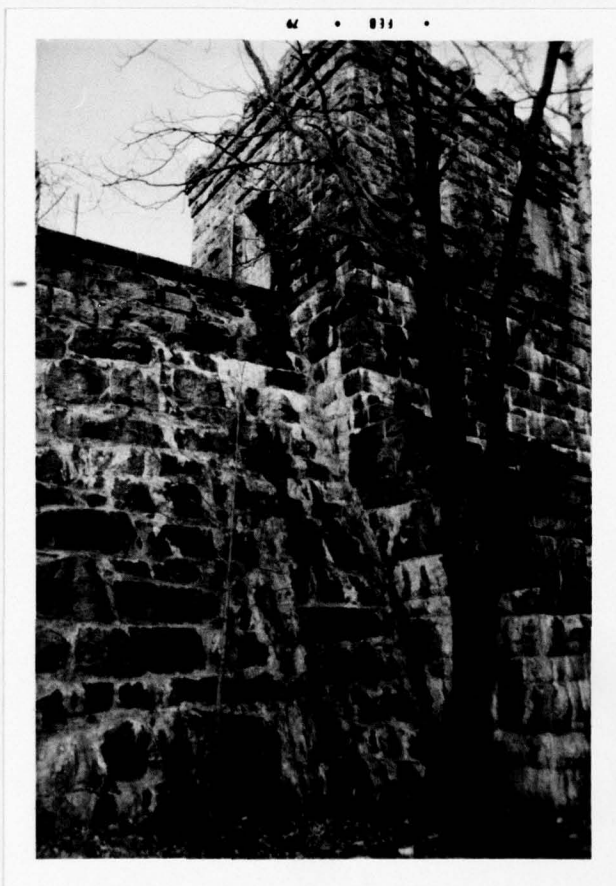
The masonry section appeared to be in satisfactory condition. There were no signs of distress or movement. The stones on the downstream face in one small area near the stone block building were wet from apparent seepage. While several of the blocks were wet, there was no actual flow noted coming through the joints. An inspection of the area immediately downstream of the toe of the masonry revealed no wet areas or soft sections.

"GATE HOUSE" LOOKING UPSTREAM - NOTE
DISCOLORATION ON BLOCKS DUE TO AREA SEEPAGE

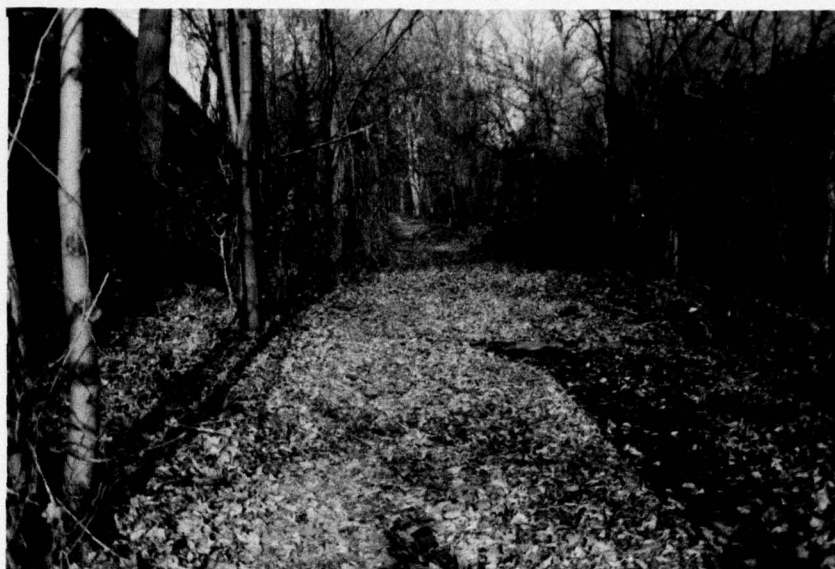
DOWNSTREAM TOE OF MASONRY SECTION
